Miroslav Vukičević
Nikola Račić
Špiro Ivošević

PISTON RING MATERIAL IN A TWO-STROKE ENGINE WHICH SUSTAINS WEAR DUE TO CATALYST FINES

Original scientific paper

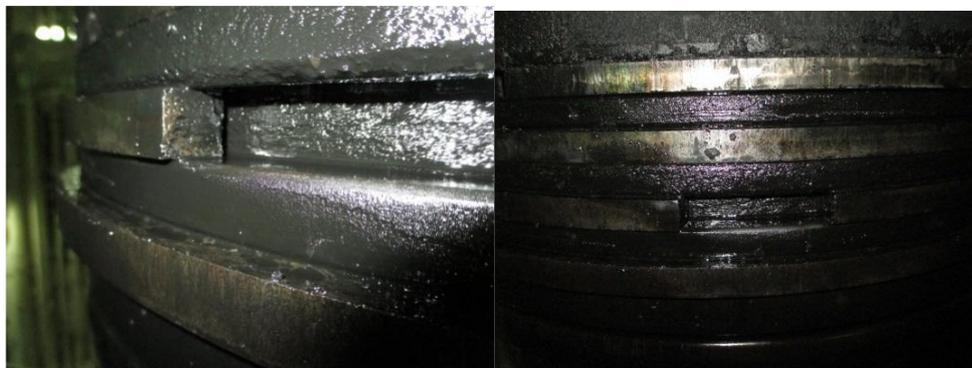
Figure 2. Damaged piston rings

During this engine type testing, the analysis involved two types of piston rings, specifically two types of the top rings that bear highest loads, with the code marks G17 SCP1RC16 and GGV SCP1CC16. There were engine problems that occurred while using the G17 RC piston ring due to the piston ring fracture (Figure 2) and the cylinder liner wear (Figure 3). The piston rings were replaced with the new chromium-plated rings of GGV CC type. The liner was replaced as well.

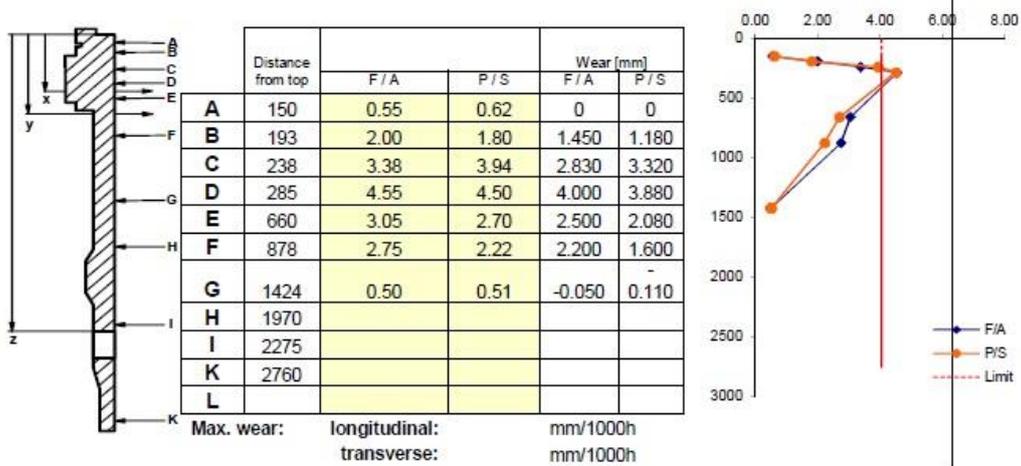
Figure 3. Measured wear of the cylinder liner

Figure 3 presents the results of the worn-out cylinder liner testing. The liner's cross-section, with the reference points A – L as points of obligatory measurement, is on the left side. The inserted table shows the distance of the measurement points from the top of the liner. The second and third columns feature the measured values (in yellow colour), whereas the deviations from the boundary values are entered into the last two columns. The measurements revealed that the high rate of wear was observed only at the upper part of the liner, as shown in the diagram on the right side, which conforms to the manufacturer's guidelines in the manual WinGD for G17 SCP1RC16 and GGV SCP1CC16 piston rings [20].

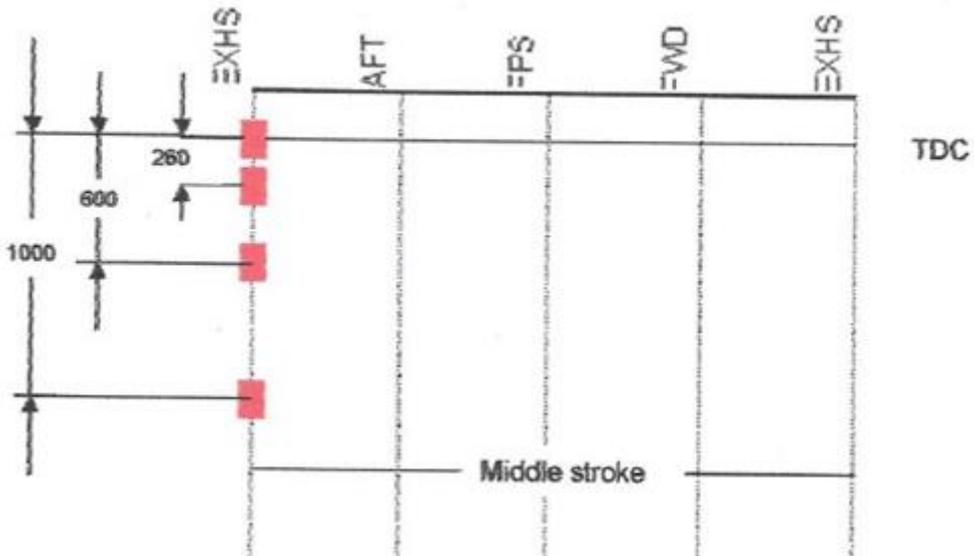
Figure 4. Replica location done at the cylinder liner

A suspicion of whether sudden liner and piston ring wear are caused by cat fines can be examined by taking a replica test of the liner surface (done together with Wartsila Switzerland Ltd. Technical services). The surface where was done replica test is shown in Figure 4 and microscope result in Figure 5.

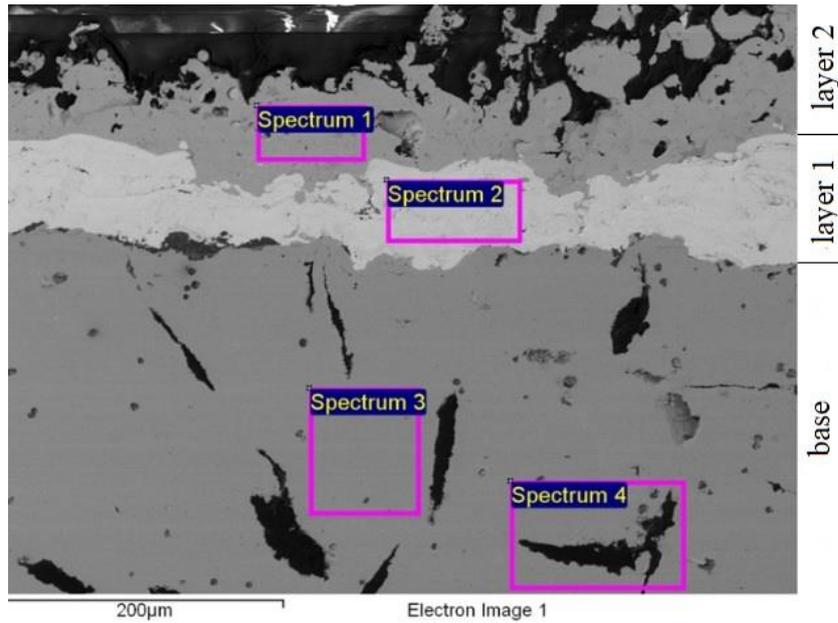
Figure 8. Analysis of elements in the observed areas of the piston ring in layers Spectrum 1 and 2 and base materials Spectrum 3 and 4 [21]

Figure 8 shows the areas selected for chemical analysis, where it is taken into account to select all visible coatings in the piston ring layer. The produced results, presented in Table 6, indicate that the piston ring base is essentially made of iron (96.4% and 68.2%). The neighbouring layer is mostly molybdenum (96%) while the last layer coating the ring is mostly nickel (92.3%). Hence this is the so-called nickel-plated ring.

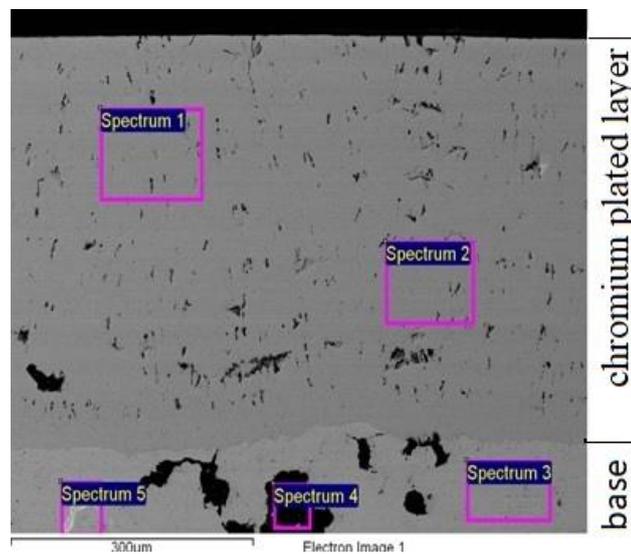
Figure 9. Polished section of composite coating Cr-Al₂O₃ by piston ring producer Goetz [21]

Figure 9 shows the enlarged areas selected for the analysis of the GGV ring. The data presented in Table 7 indicate that there is only one chromium layer as the ring's plating (96.4% and 98.9%), whereas the base of this ring is also essentially made of iron (96.4% and 81.2%). Therefore, this ring can be called chromium-plated. The small particles are alumina particles ($O_2=1,95$ Table 7). Between the galvanic deposited Cr-layer and the cast iron surface is a Cu interlayer.

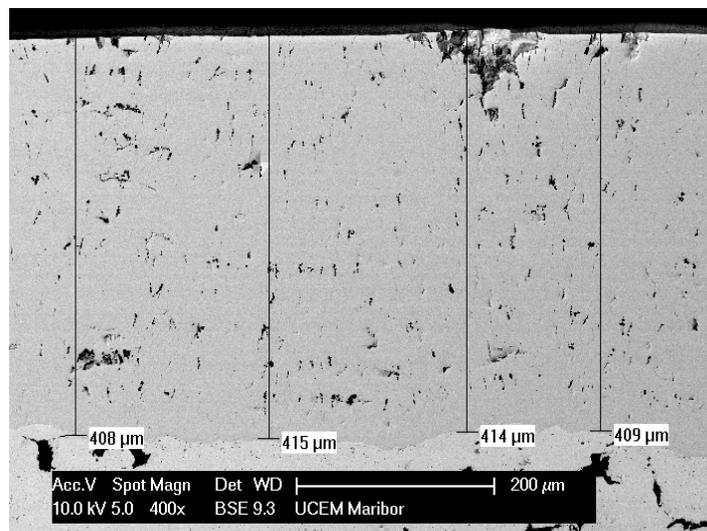
Figure 10. Thickness of the Cr-Al₂O₃ coating on the Top ring GGV examined by electronic microscope (SEM) [21]

This segment of the research focuses on the layers of the GGV and G17 piston rings. When observing the plating of the top ring GGV, it can be noticed that this ring has a thick layer of chromium amounting to 400 μm , while the micro-structure of the base material features simple graphites (Figure 10).

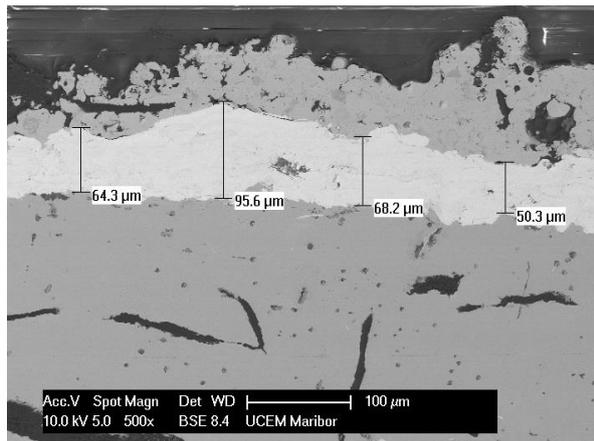
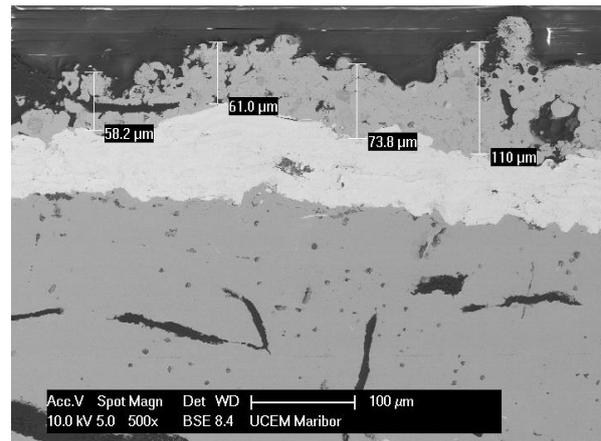
In contrast to the GGV ring, the G17 Top ring has a completely different structure of the surface layer. In Figures 11 and 12, two different platings can be noticed, having the maximum thickness of 95.6 μm and 110 μm respectively. The prominent feature of this ring is the overall thickness of its layer (205 μm , both platings). It can be noted that this value is double in the chromium-plated ring.

Figure 11. Thickness of the plating in the lower layer of the G17 ring

Figure 12. Thickness of the plating in the upper layer of the G17 ring

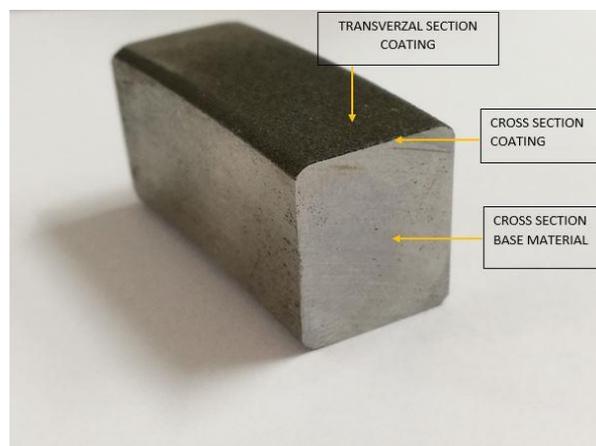
Figure 13. Points of measurement for Vickers micro-hardness [21]

The points of the micro-hardness measurement are shown in Figure 13. The procedure established that the Top ring G17 had a greater average hardness of the base material, amounting to 306.5 (HV 0.2). However, its hardness at the cross section coating is only 385.5 (HV 0.2), which indicates that the surface layer of the ring is just a bit harder than its base material.

On the other hand, the chromium-plated Top ring GGV has 217% greater hardness of the coating, amounting to 838.17 (HV 0.2), as presented in Table 8. This is essential in terms of abrasive wearing because the surface layer (coating) makes a physical contact with the cylinder liner, lube oil film and catalyst fines.
